Safety Alert: Study Reveals Sharp Increase in Deck Failures

A landmark study reveals that there have been 179 reported deck collapses from January 2000 through December 2006, killing 33 and injuring 1,122.

By: Michael Morse,
Brittney Corwin,
Robert Morse and Andrew Johnson

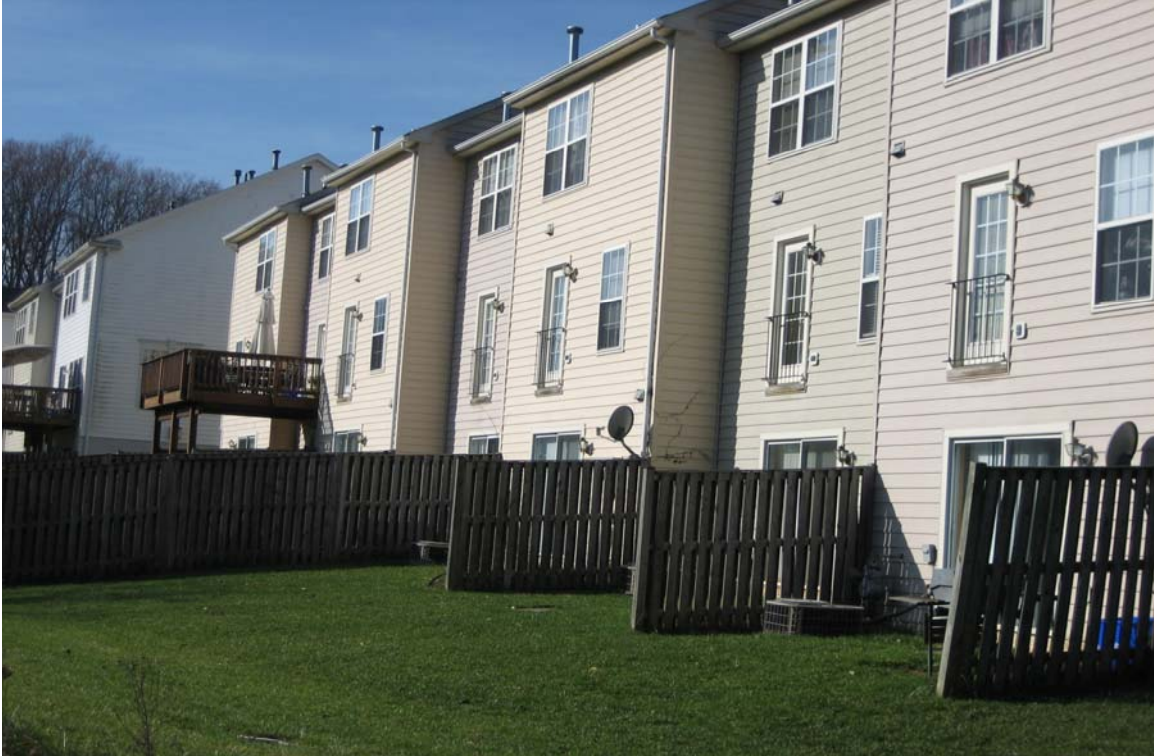
Subdivisions, such as this town-house community, can be found across the United States. It is clear that these homes were designed to include a structure outside of the rear door. The rim joist located just below this door was intended to be the point of attachment for the future deck.

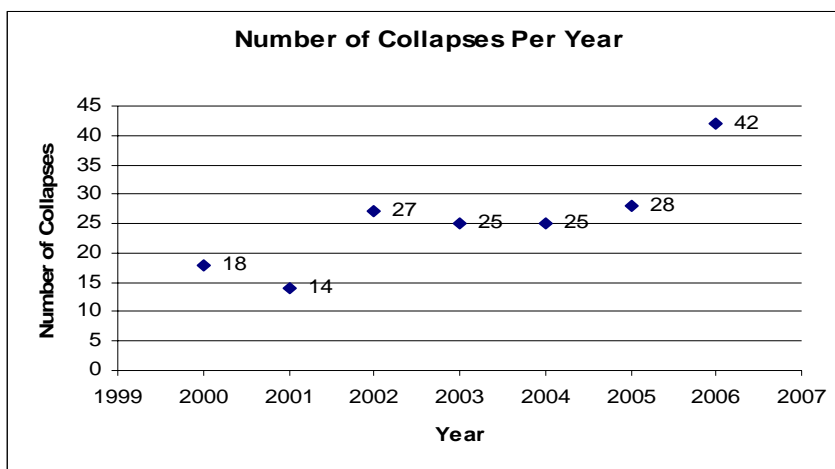
- Deck collapses are increasing at an average rate of 21% per year.

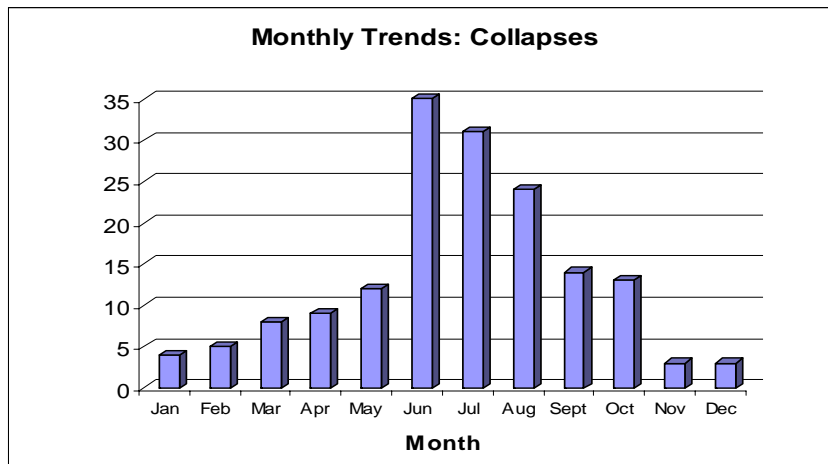
- There is a well-defined deck collapse season (June through August) in which over twice the number of deck collapses occur as compared to the rest of the year.
